This publication is a shortened English version of the book with the same title,
initiated by the Upper-Tisza Water Authority and produced with
the cooperation of VIZITERV Consult Ltd.

I. INTRODUCTION

II. THE HYDROLOGICAL DESCRIPTION OF THE FLOOD-WAVE

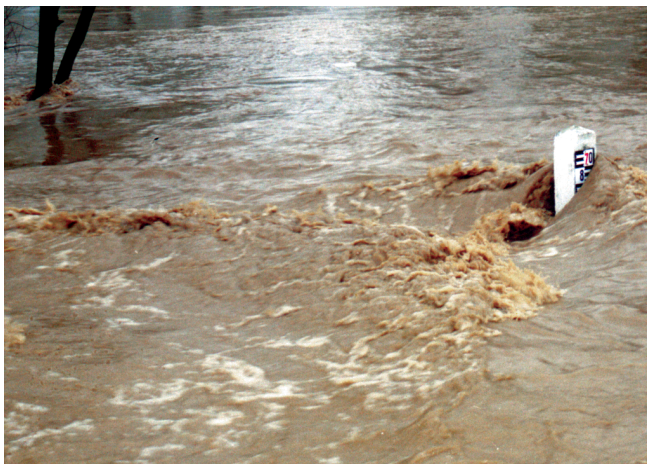
The water gauge at Tiszabecs in the afternoon on 5th November 1998. The measured water stage was 6800 mm

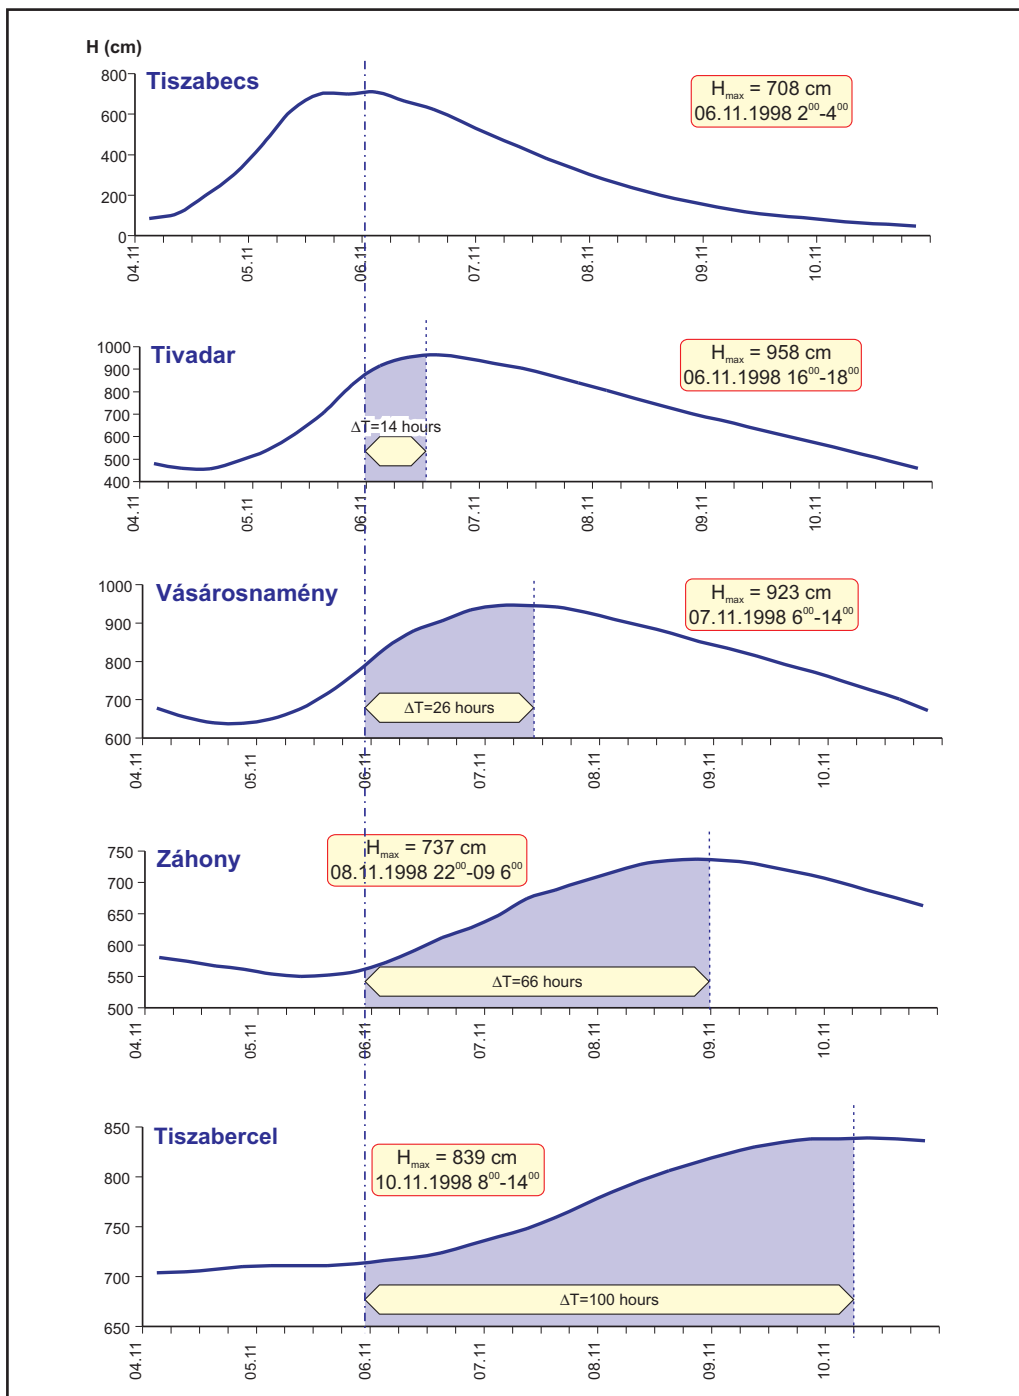
Flood hydrographs and time characteristics of progress of floods on the Hungarian territory of the Upper-Tisza

where exceeded the highest stage ever measured. The checked and corrected peak water stages: Tiszabecs 7080 mm, Tivadar 9580 mm, Vasarosnameny 9230 mm.

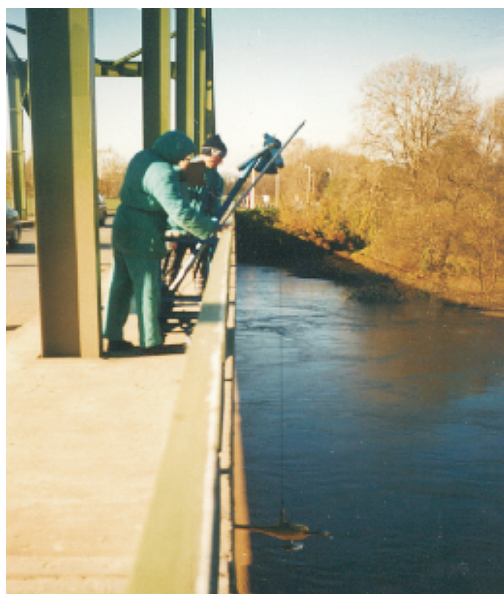
*Flow measurement on the Tisza
at Vasarosnameny 7th November 1998
at 9230 mm water stage*

November) 3220 m³/s. Based upon these measurements, it can be stated to all probability, that the May 1970 4160 m³/s of Tiszabecs published in 1971,⁹ was about 30-35% overestimated. The measurements provided useful results for calculations of the discharge capacity of both the main river course and the floodplain. The low proportion of flow of the floodplain compared to the main river is obvious (Tivadar 15-20%, Vasarosnameny 2-16%).

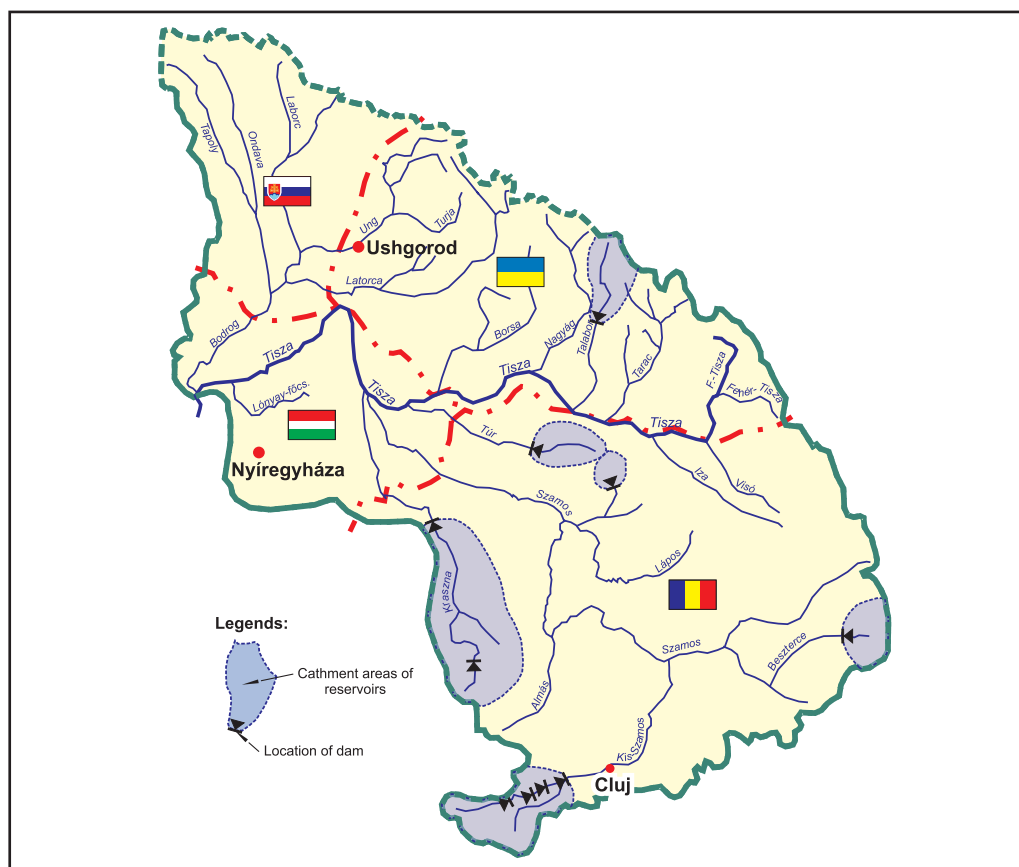
Major water reservoirs and their catchment area of the tributaries of the Upper-Tisza

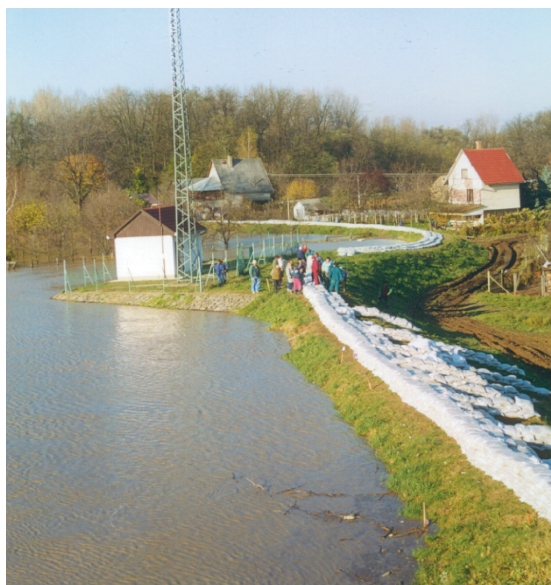
*The hydrological remote sensing station
in Vasarosnameny, on 8th November 1998*

The hydrological remote sensing network consists of 10 units:

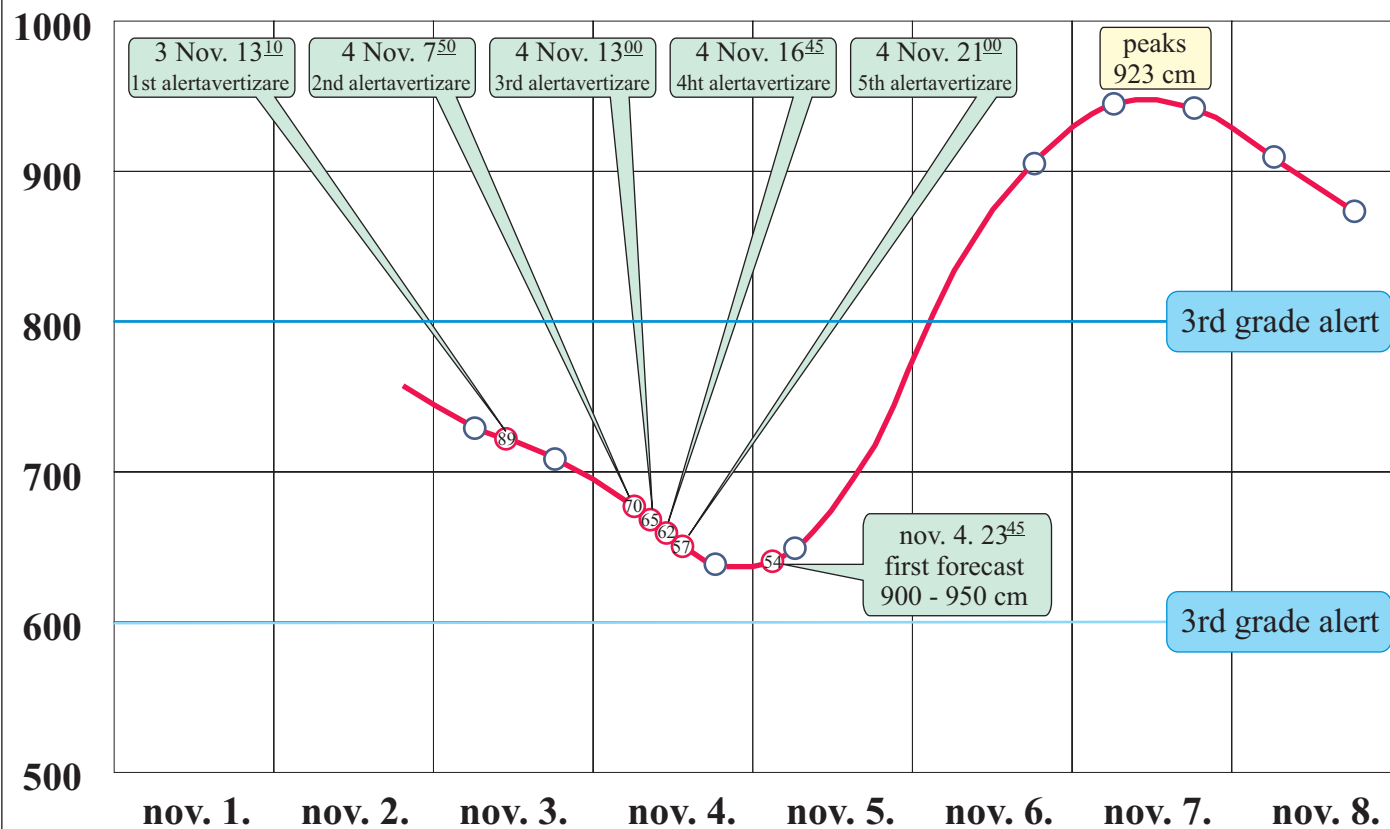
The lead-time of hydrological forecasts for Vasarosnameny issued 4th – 7th November

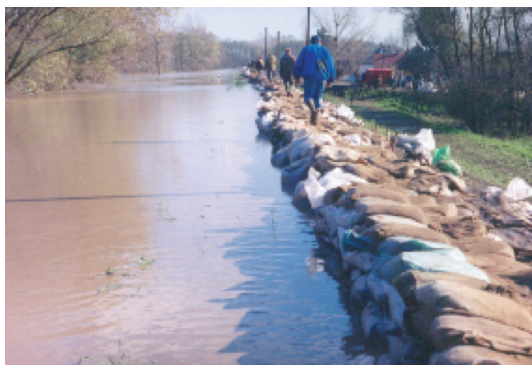
Along the section of Tizsakorod-Tizabecs it was necessary to build emergency dams to avoid overtopping. The emergency dams held 10 to 50 cm, at some places 70 cm, water above the crest along a more than 4 km-long section. Along a further 1.5 km section the water approached the crest by 0 to 50 cm. For a few months prior to the flood there were dike strengthening constructions done in the fields of Milota, which could not be completed before the arrival of the flood waves, so the open dike had to be fixed and heightened.

*Heightened dike at Tiszacsecse
on 6th November, 1998.*

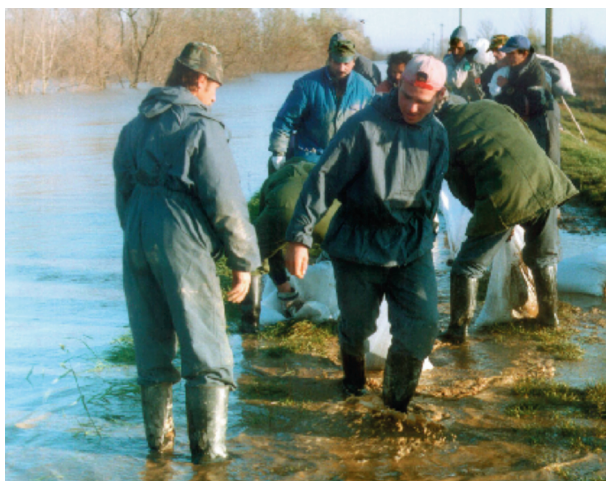
Increasing the height of the dike at overtopping water

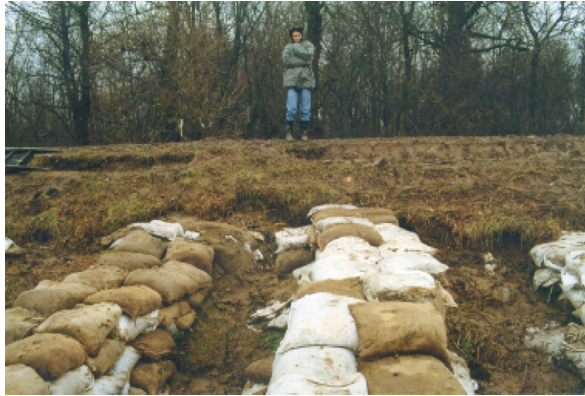
At 23.00 on 6th November at a water level nearing the height of the crest, the stability of the soaked and saturated, loose dike body became critical due to the following factors: dike sections with small size and high seepage coefficient, damaged slope on the protected side, ditches that formed along the protective zone of the protected side, thin covering layer, backwater effect because of the distributed load. On the slope tension cracks formed and a 15 -17 m long stretch, between the sections 62+533 – 62+551 km slid. A soil mechanics disclosure stated that the damage is the result of a slough or an underground breach.

Construction of an excess weight band at the slough at Tarpa along the frontier at night on 7th November 1998.

The local flood control management immediately began to dismantle the sandbag coverage and transform them into excess weight bands. By constructing the most important weight band the section was stabilized before 2.30 on 7th November, however, until the dismantling of the sandbag coverage, the construction of the excess weight bands, the construction of the drainage net between the bands the condition of the dike was not reliable, the risk of having a breach existed. 34 sandbag bands were built along the 83 m long section. As a result of the quick reaction the problem was localized in an early phase of the phenomena, the breach was prevented.

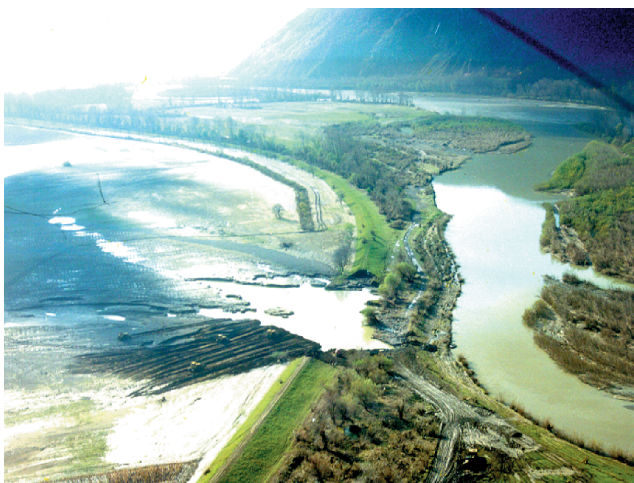
The dike breach below Királyháza (Ukraine). It happened between 14.00 and 16.00 on 5th November 1998

restoration work was done by the water construction firms. For the restoration a total of 17,600 m³ stone was used up and 443,600 m³ earthwork was done. A 6.5 km long flood protective dike section and 24.4 km riverbed were renovated and restored. A 3.4 km long river section was cleansed and 42 acres of island together with the floated timber.

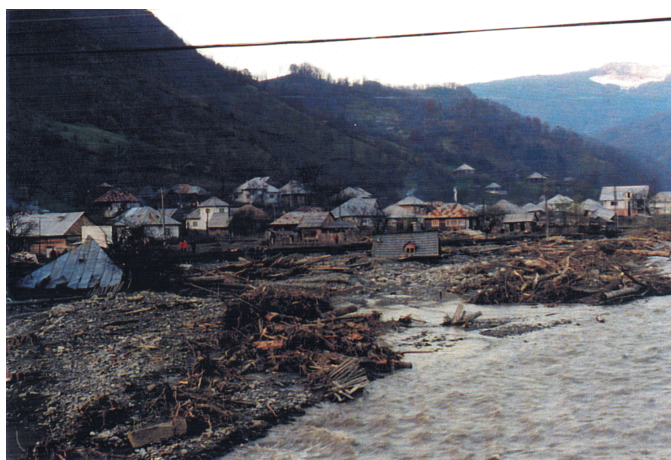
After-flood situation in the basin of the River Oroszi
