THE UPPER-TISZA FLOOD IN MARCH 2001

Shortered version

This publication is a shortened English version of the book
with the same title,
Initiated by the Upper-Tisza Water Authority and produced with
the cooperation of VIZITERV Consult Ltd.

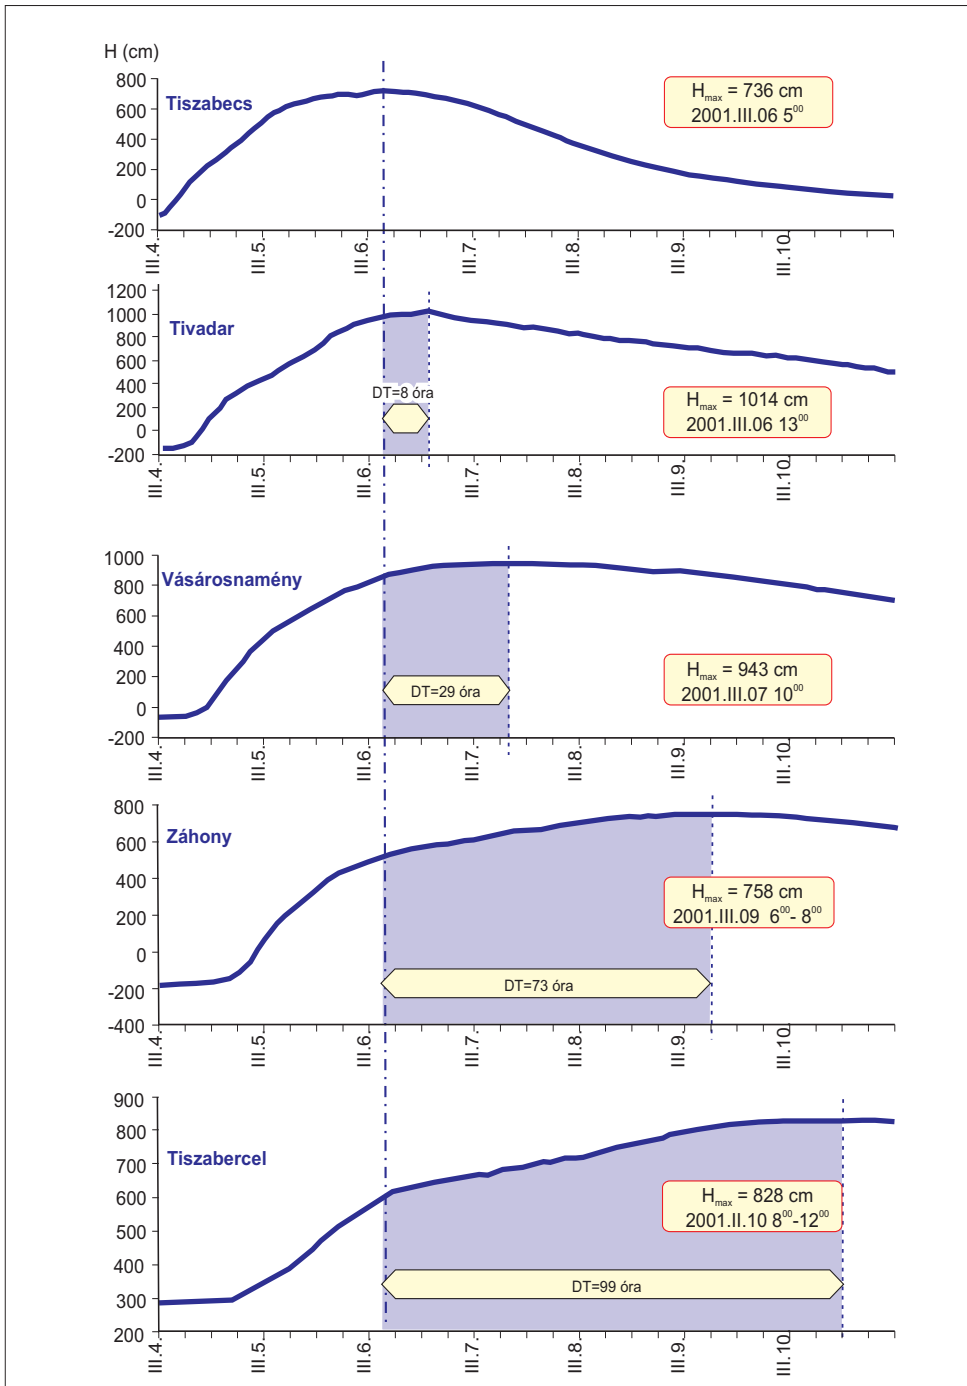
Flood hydrographs and times on the Hungarian section of the Upper-Tisza

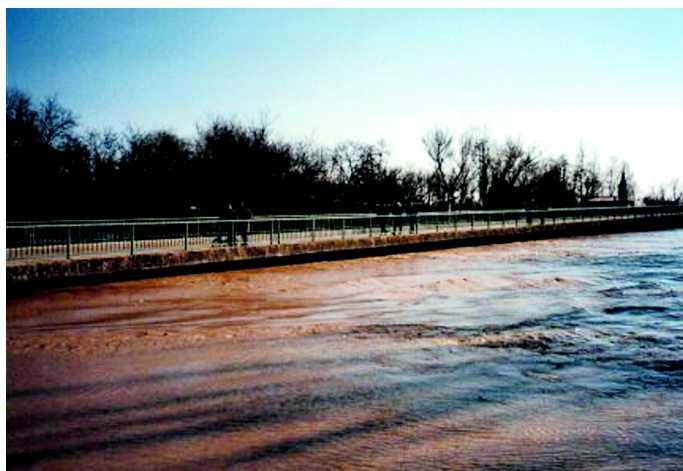
The Tivadar bridge section (06 March 2001)

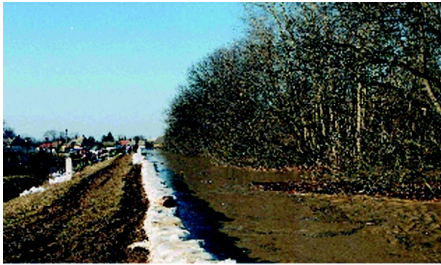
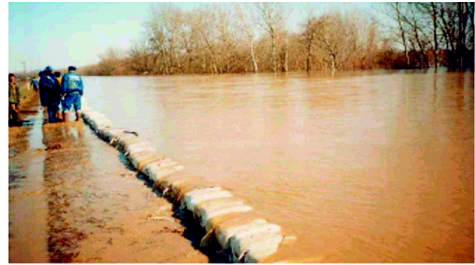
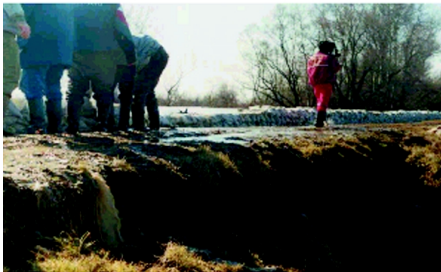
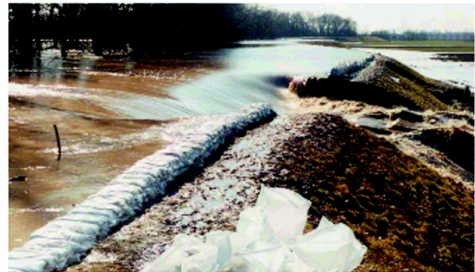
Process of the dike breach

dike breach was unavoidable. In an hour's time the water broke through at two other locations at the same time and in a short while the two break-through washed together and another breach happened. There was no chance to stop the water. At Tivadar the Tisza had its peak with 1014 cm water stage, which was 56 cm higher than the one in 1998 and 149 cm higher than water stage in 1970. Before the dike breach at 13 hrs 30 min on 6th March, a 30 km long emergency dike had been built along the upper section of the Tisza, in hardly more than a day. Five flood control squads with 234 workers, 9 teams of civil guards with 450 people, 1200 soldiers, 2600 human force, altogether 6000 people plus were working on the levee sections on 6th March. 150 local plus 180 partner water directorate employees carried out the technical management.

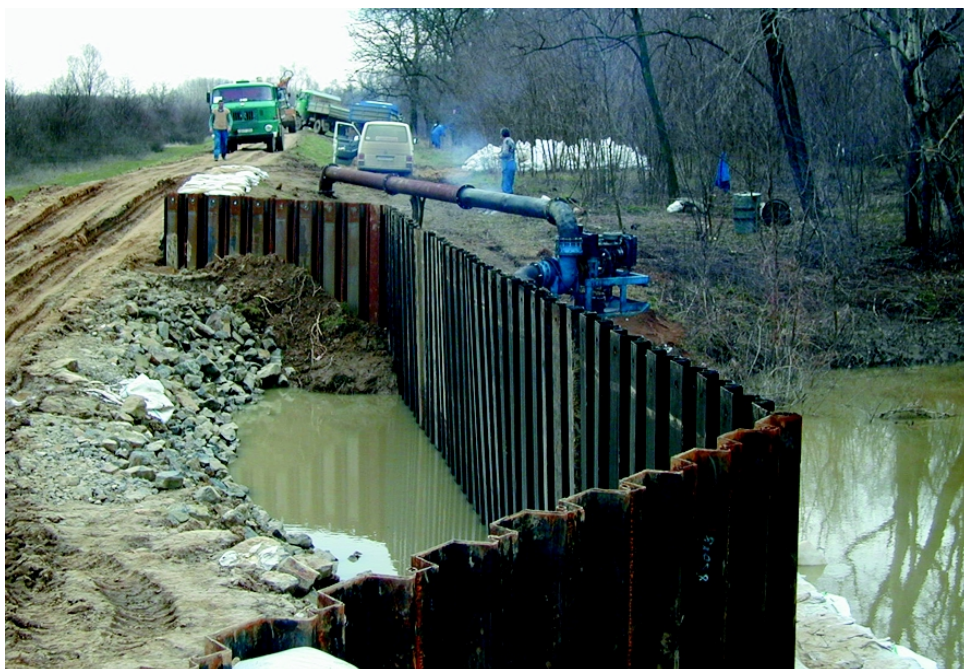
Completed blockage by sheet piling at 12+000 left bank section of the Tur

- Cut down the top of the dike to 1.5 m height in the vicinity of the edges, fill the gap, and dry up the depression.
- Transport sheet piling to the location of the breach, prepare sheet-piling work.
- Examine the dike material and its condition, prepare borrow sites (Kisar).
- Transport and deposit other building material (TERFIL, sand-gravel, crushed stones).
- Construct approaching road. The construction of the road along the foot of the dike was done from two directions.

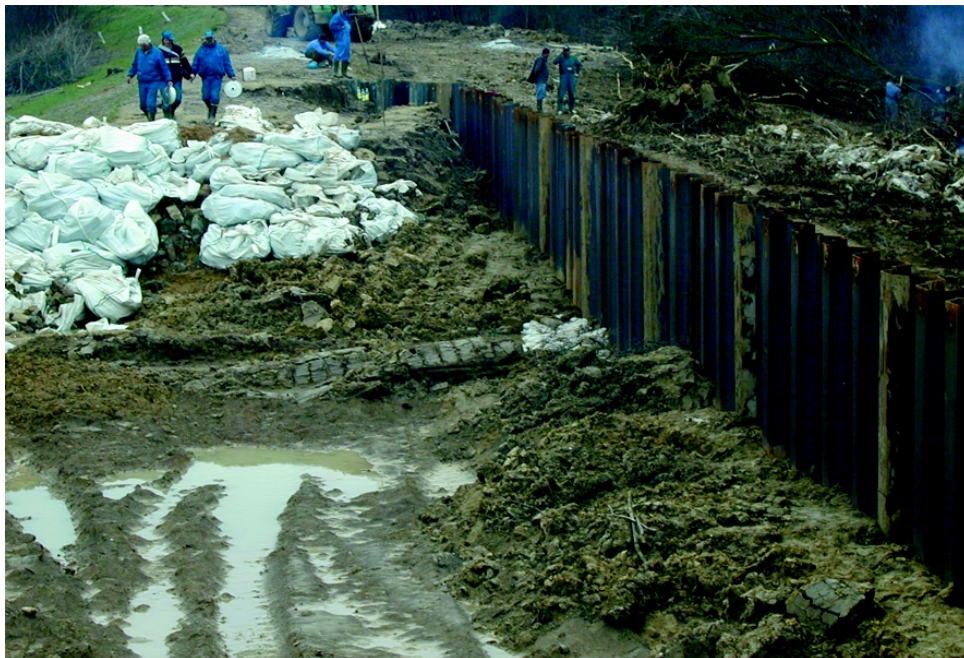
Completed blockage by sheet piling at 12+400 left bank section of the Tur

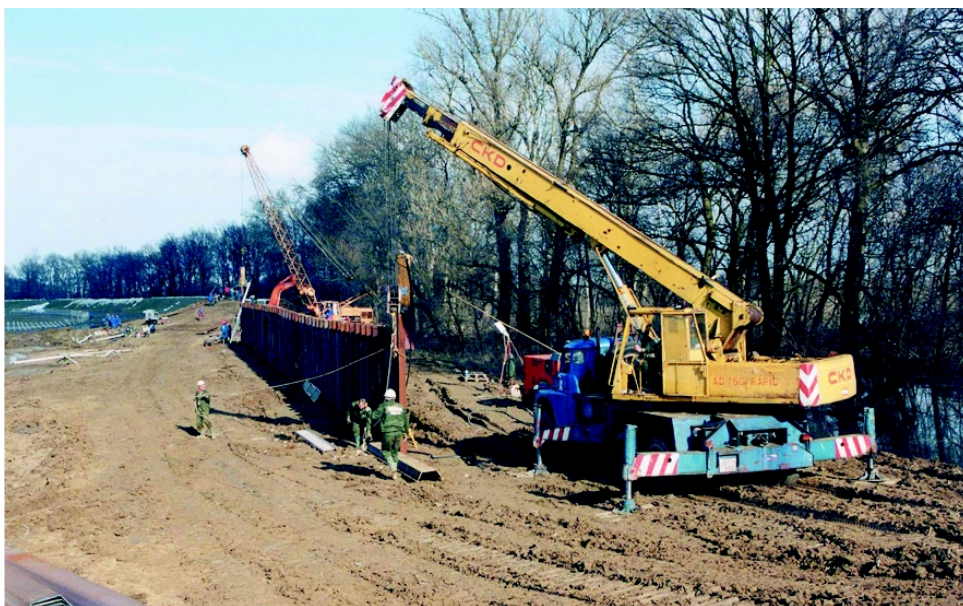
Sheet piling of the downstream dike breach

The design was approved by the National Technical Flood Control Committee, the implementation immediately began. Sheet piling work commenced on 11th March and the provisional blockage of the breaches with LARSEN sheets was completed in record time thanks to hard and organized efforts of flood control squads ordered to the spot (ÁBK SZ, ÉDUVIZIG, KÖVIZIG). It was completed by 14.00 on 14th March and 16.00 on 15th March.

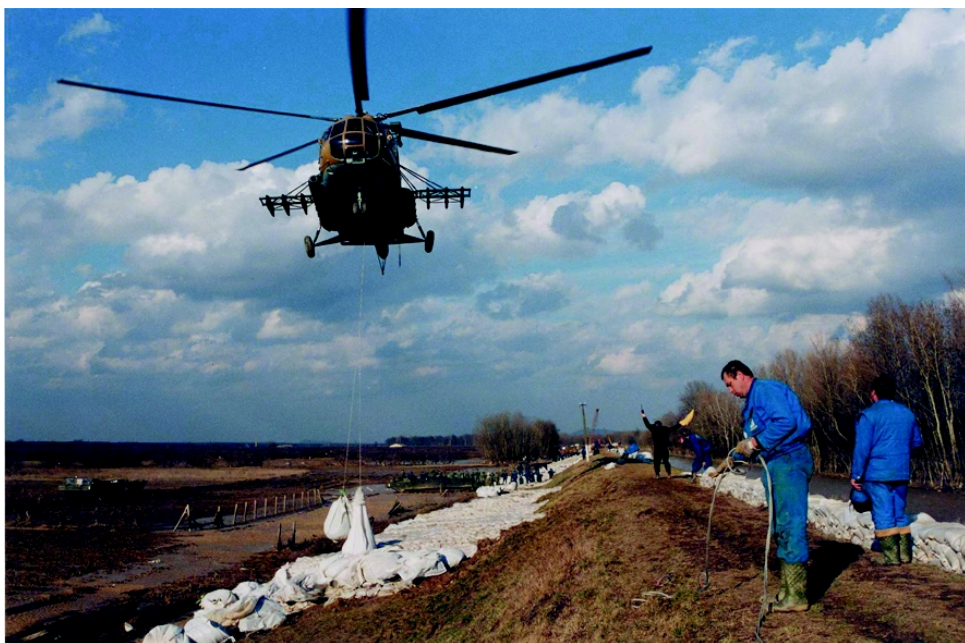
Helicopters assisted at the construction of the excess weight stone band

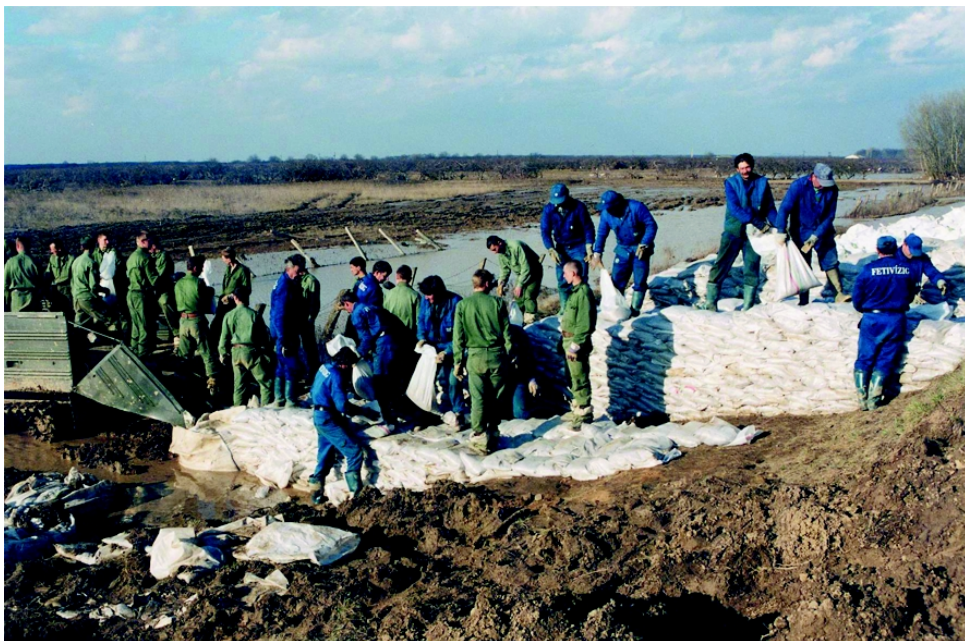
Constructing excess weight stone band with the help of the army

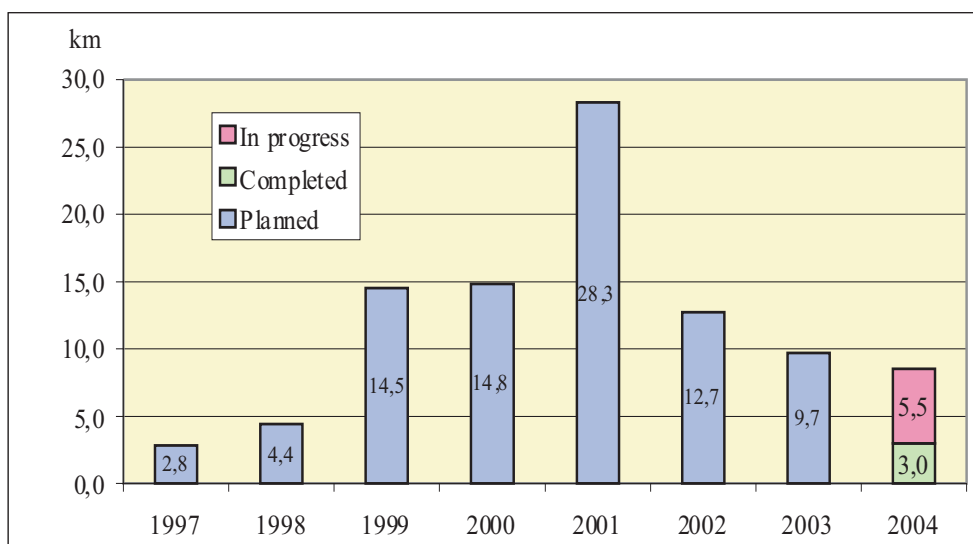
Accomplished dike developments

As a result of the development that started in 1997, the condition of the flood management has improved. *From 1997-2004 the reinforcement of a total of 86.20 km dike was completed*, however, 44 km still remained urgently to be done. The reinforcement of the remaining 130 km is important as well. Presently (in 2004) 35% of the total flood protection dikes is lower than it is required. From the flood management point of view, river regulation is also important. There are 26 sections on the
